Buying Right - C3

Shopping for a third-generation Corvette? These tips will help steer you in the right direction.

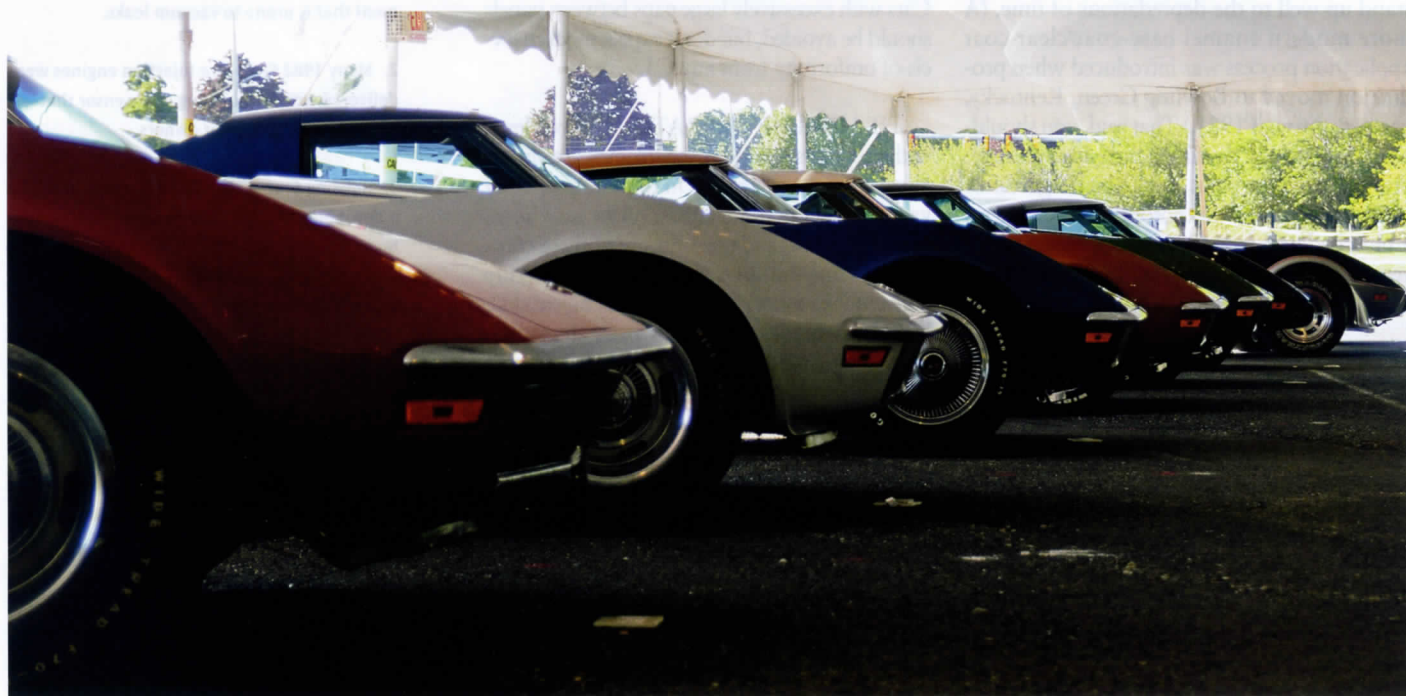
1. C3 base engines like this 1971 350/270 tend to be admirably robust, but some later models are equipped with emissions-control equipment that is prone to vacuum leaks.

they have the additional benefit of being able to operate on unleaded fuel. Just keep in mind that the crude emissions devices employed at the time are prone to vacuum leaks that may mimic fuel-starvation issues. Bring along a vacuum gauge to help diagnose such problems, which typically aren't all that difficult or expensive to rectify.

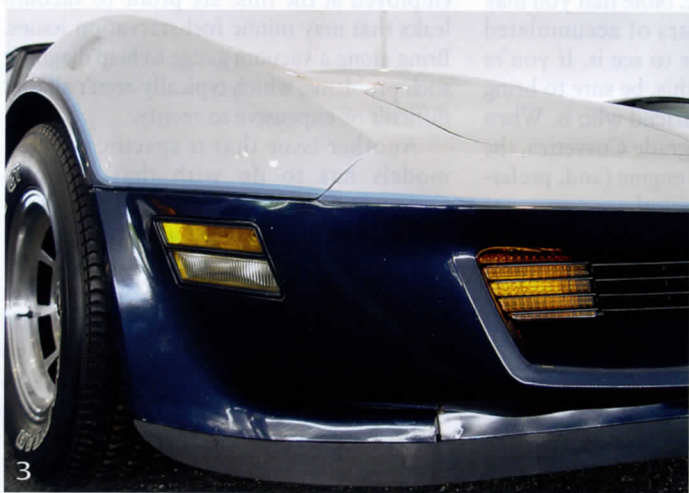
3. Bowling Green-built Corvettes featured a new paint process and improved body-panel fit.

PAINT - C3s built at the St. Louis assembly plant received acrylic lacquer paint that did not stand up well to the depredations of time. (A more modern enamel base-coat/clear-coat application process was introduced when production moved to Bowling Green, Kentucky, partway through 1981.) That said, you shouldn't automatically dismiss a nice, low-mileage, pre-'81 car whose paint looks a bit rough. Silver paint, in particular, was notorious for taking on a blotched and faded appearance after a few years of sitting in the sun, and yet the mechanics beneath could still be quite sound.

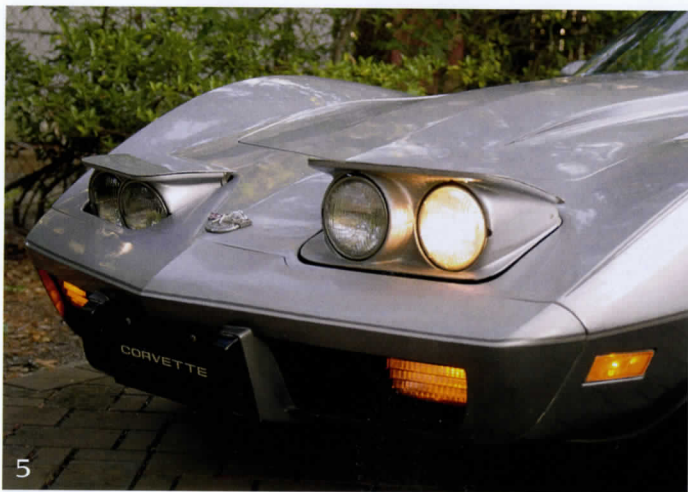
5

5. Droopy headlamps usually indicate a vacuum leak from a hose, relay or actuator. Use a vacuum pump and gauge to test system, and replace or rebuild components as needed.

HEADLAMP OPERATION - Problems with these cars' "pop up" headlamps are almost always vacuum related. On the C3, a series of vacuum-operated actuators, relays and hoses raise the lamps, and one or more of these components may fail over time. Effecting repairs here requires more patience than technical skill, but even a novice with a few basic diagnostic tools should be capable of doing so. This also goes for the vacuum-operated windshield-wiper cover on 1968-'72 models.

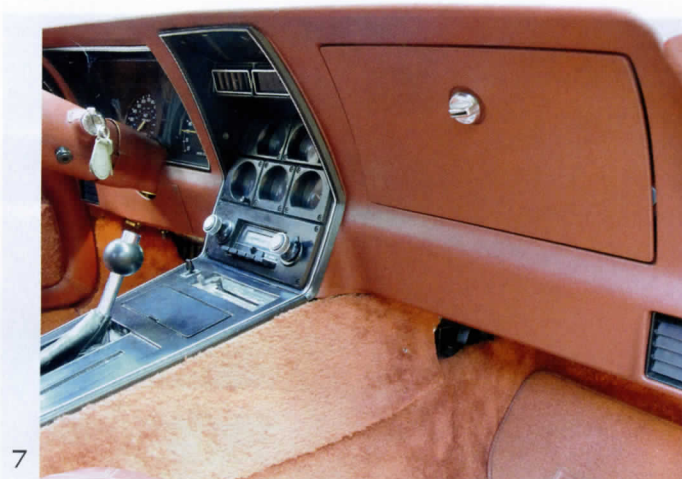
7

7. The glove box returned with the 1978 model. More importantly, the redesigned dash allowed owners to access tach/speedo and console systems without removing the entire dash.

From 1968 through '77, the Corvette's interior remained essentially the same, albeit with minor changes and upgrades that can make it difficult to track down precisely the right replacement parts. A major interior redesign arrived for the model's 25th anniversary in '78, bringing with it numerous comfort and convenience upgrades. Perhaps more noteworthy,

it's possible on these later models to access the car's speedometer/tachometer cluster for repairs without tearing the dash apart.

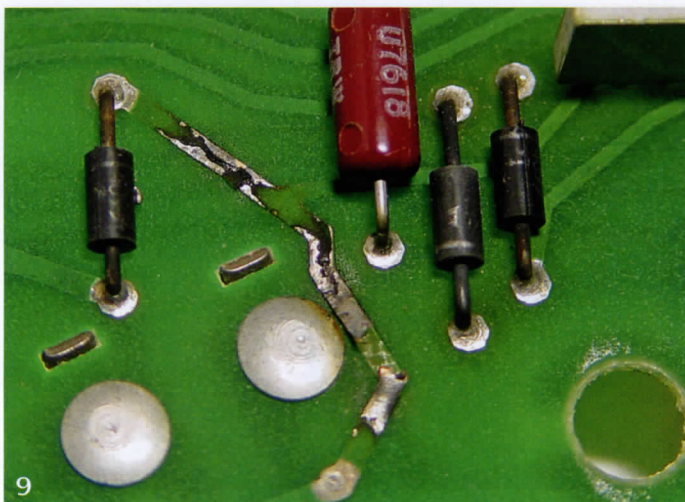
9. Early circuit boards tend to fail over time, usually due to inadequate copper circuit paths. This unit shows evidence of severely deteriorated paths.

ELECTRONIC CIRCUIT BOARDS - Starting in the mid 1970s, Chevrolet began installing electronic circuit boards to operate the Corvette's tachometer, courtesy-light timer, low-fuel monitor and 30-second headlight/igni-

tion warning buzzer. If any of these items is nonfunctional, it's likely that its related circuit board has failed. Although today's widely available replacement units are built to a much higher quality standard, accessing the affected area can be a chore.

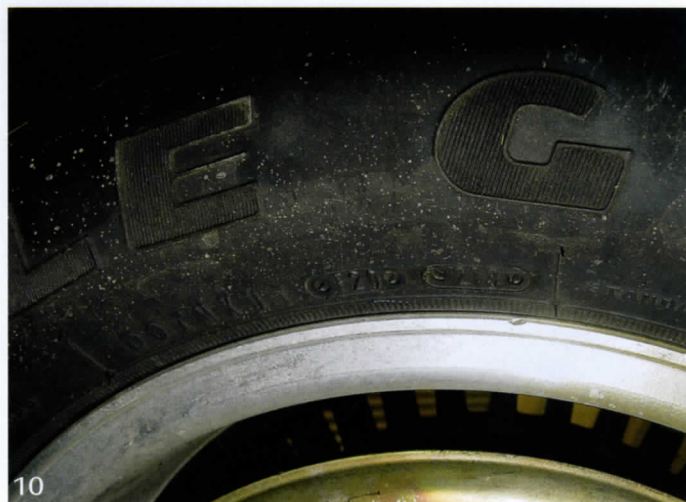
10. Starting in 1971, all tires sold in the U.S. received a three-digit code tied to their date of manufacture. In this case, code 213 means the tire was made during the 21st week of 1983.

TIRES - Sellers love to extol the virtues of original tires, but by now such tires on a C3 will be well past their sell-by date. Check the date codes (see caption) and look for cracks, dry rot and tread wear. A number of specialty manufacturers today offer both bias- and radial-ply tires in a variety of C3 sizes and

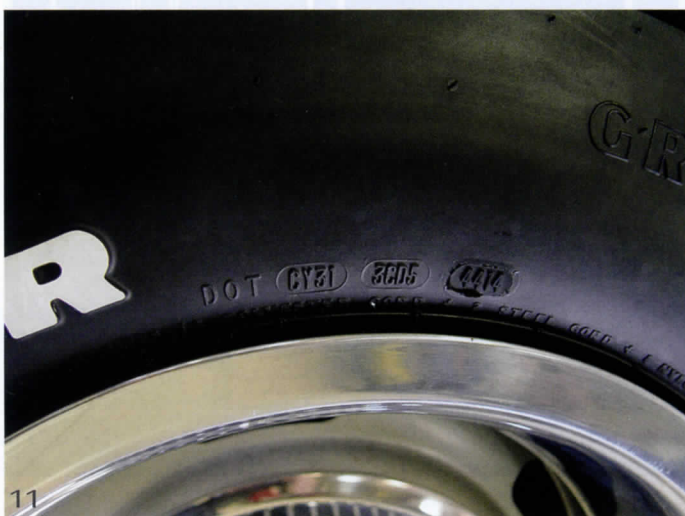
11. In 1997, the coding convention changed to a four-digit sequence. This tire's code, 4414, refers to the 44th week of 2014. Note that most manufacturers advise against using any tire that is more than 10 years old, regardless of its condition.

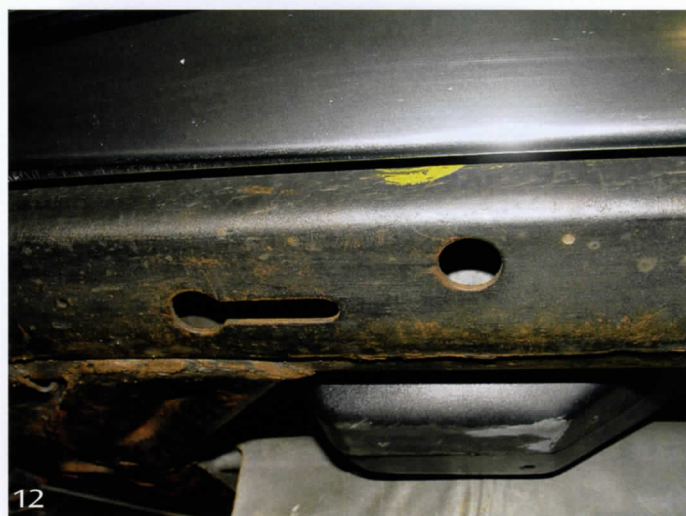
12. It's important to check for frame rust on any potential C3 buys. Frame slots like these make it easy to reach in and feel around for corrosion.

FRAME RUST - Frame rust can be an issue on any vintage Corvette, and the C3 is no exception. The most problematic area is the rear “kick-up,” in front of rear wheels, but the entire chassis is susceptible. Surface rust can typically be removed with a wire brush or sandpaper, but deeper corrosion will require costly repairs.

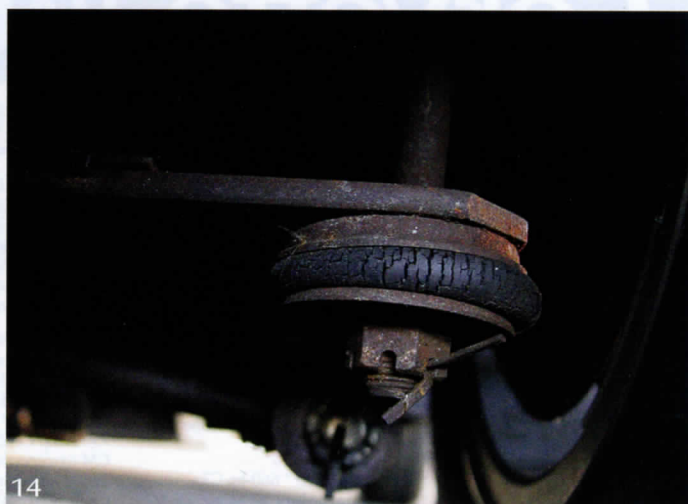
14

14. Slightly cracked suspension bushings—like this rear spring-link unit—are common, and don’t necessarily need to be addressed right away.

SUSPENSION - C3 suspensions are pretty robust overall, but time, hard use, deicing salt and other factors can take a toll. Inspect the rubber bushings in the front and rear suspension, looking for drying, cracking and other deterioration. Small cracks are not unusual, but heavily damaged bushings will need to be replaced. This isn’t a terribly expensive job, but it does require the use of special tools and, preferably, a lift. ○

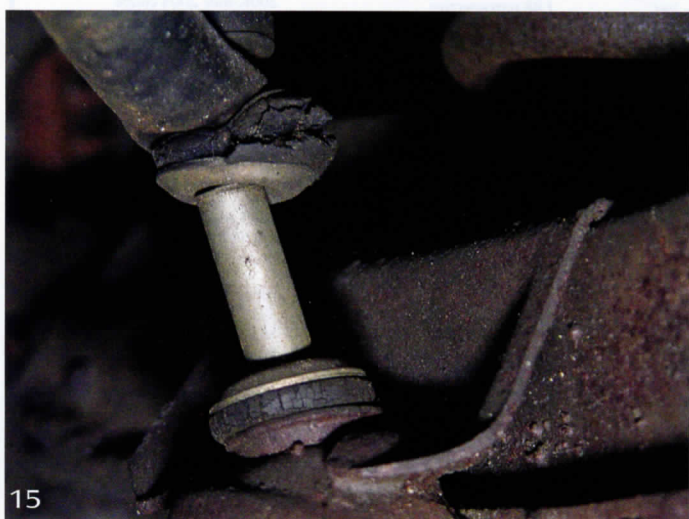
15

15. The top portion of this front stabilizer-bar bushing is cracked and failing, making this unit a candidate for replacement.
