1978 Pace Car: The Final Process

by Tom Russo

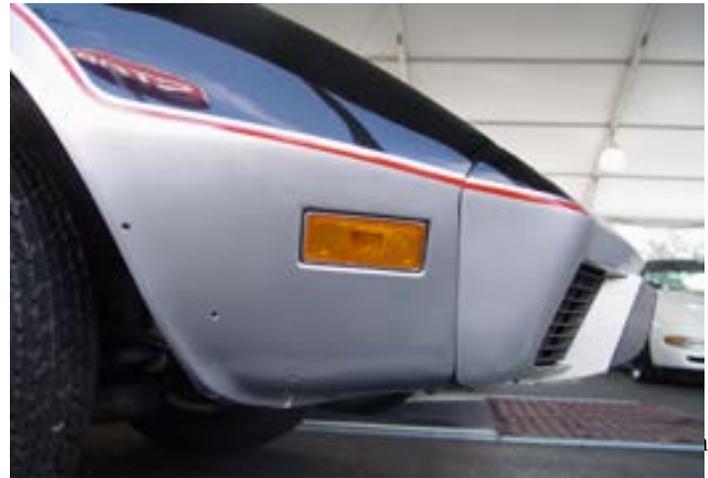
Figure 1: 1978 Pace Car as delivered to dealer without front air deflector installed.

The nose, as noted above, pre-painted and factory-installed was masked with the masking tape/paper to protect the grill, nose and side lamp lenses at the masking station as workers prepared to paint the fenders and door in the paint booth. In the process of applying the masking tape/paper mask, the worker wrapped the tape in a straight line rather than follow the curvature of the fender/nose seam. As a result, this technique captures a portion of the unpainted fender to secure the mask. A close look at Figure 1 also reveals the initial formation of the black triangle. Figure 1 features VIN 01977 and Figure 3 shows VIN 01058.

In January 2014, the Roger Judski, seven-mile 1978 Pace Car was sold at auction. It was presented as received by the dealer in 1978 and sold to the buyer (Roger's Corvettes) without dealer preparation. Its MSO status had been retained since the buyer took delivery. In the rear storage compartment, in addition to the single decal box, was stowed floor mats, wheel caps, and the three-piece front spoiler in three individual plastic bags (Figure 5). The front fender was pre-drilled to mount the spoiler and silver paint is seen inside the holes. Each photo in Figures 1, 2 and 4 show a spoiler-free front fender with silver-tainted mounting holes.

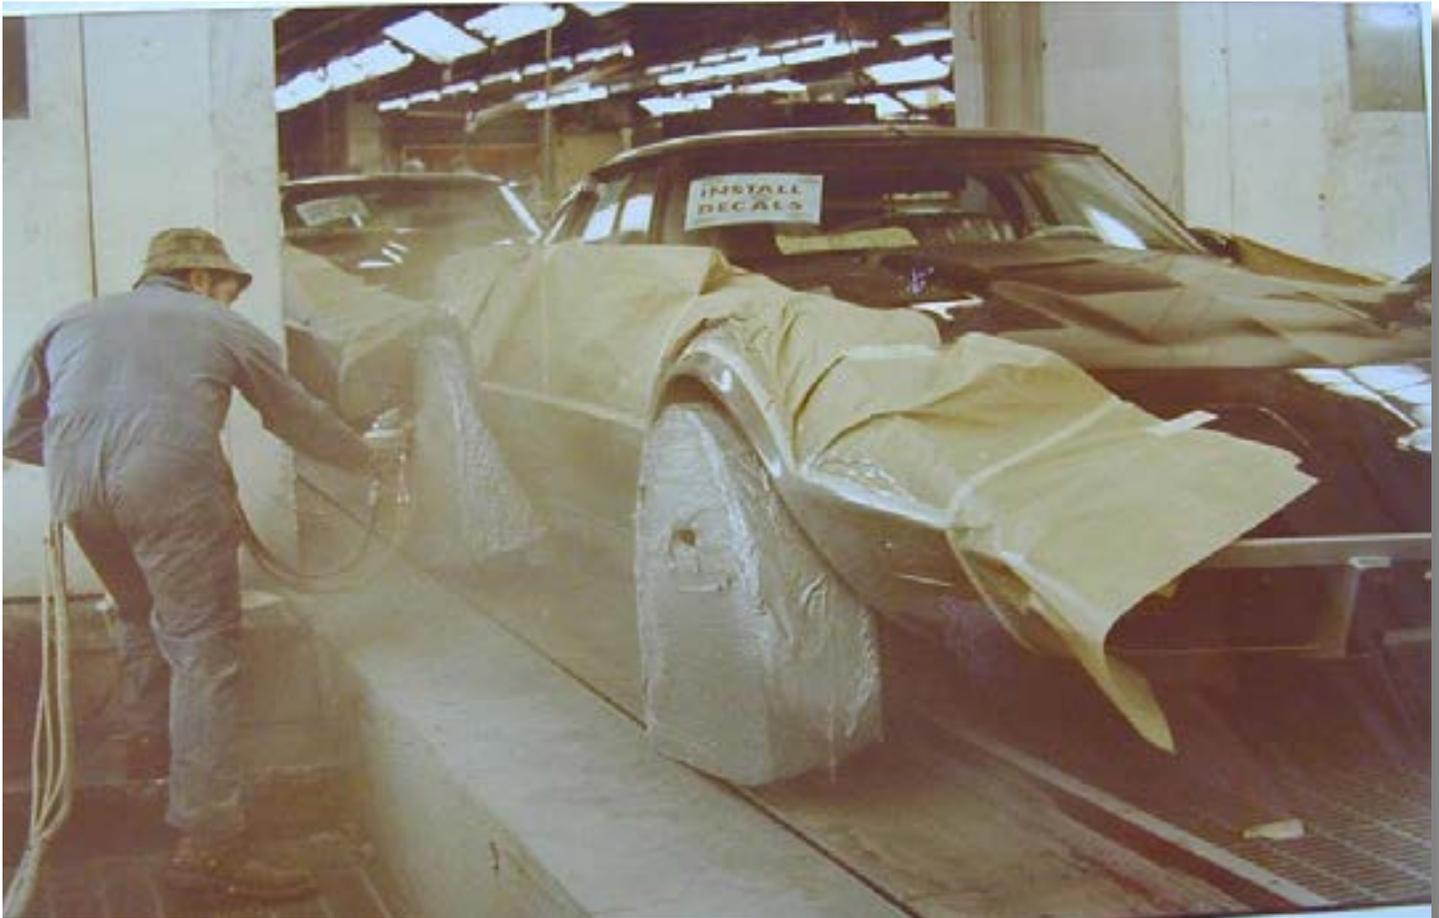
One particular photograph from 1978 (Figure 2) shows workers painting the lower half of a Pace Car with “hot” metallic silver paint (code 47). Note the masking of tires and the paint line where silver breaks with the black paint above it. At the bottom right of the photo, open steel grating within the floor is seen that reduced overspray above the level of the masking paper. The booth had blowers and suction with downdraft airflow through this grate system.² Attached to the windshield is a note to workers further on down the line to INSTALL DECALS.

Figure 2: Pace Car In Final Process of main plant

Silver paint on the stabilizer bar verifies that the bottom portion of the body was painted after the body was assembled to the chassis. The patterns of paint spray on the bar are typically sporadic rather than a uniform pattern, suggesting overspray from the paint process rather than a deliberate spray pattern. The worker's posture in Figure 2 shows that workers stood while spray painting with some stooping to get the lower portion of the body.

Note the silver-painted urethane front bumper in Figure 2. The bumperettes are shown black and the nose silver. Because bumpers were made of RIM urethane (reaction injection molding), and required a flexible paint process, in contrast to the conventional acrylic lacquer used in 1978, bumpers came to the assembly plant already painted. Speculation is that bumpers were molded at the GM Guide Division, Rimir, Mexico plant and shipped to St. Louis.¹

Over the years, Pace Cars presented on the judging field without an installed spoiler. All three parts were stowed in the rear storage compartment wrapped in plastic. In a rare black and white photo, Figure 6 captures VIN 6502 perched on a freight truck without the spoiler. Earlier, Figure 2 showed a Pace Car in the paint booth without its spoiler. The three-piece spoiler was painted separate from the body.

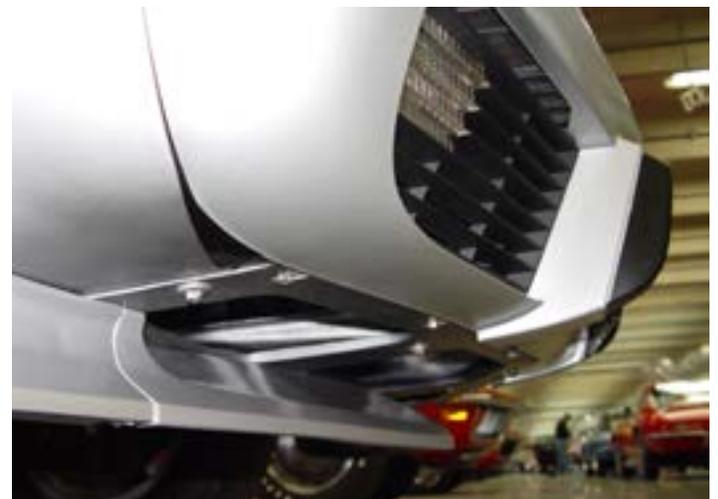
A third paint anomaly (Figure 3) observed on a number of Pace Cars illustrates a particular worker's technique of applying the masking tape/paper protection on the nose. Note the black paint triangle form at the fender/nose seam as it wraps underneath and out of view.

Figure 3: Pace Car sports black paint triangle.

This paint anomaly noted on a number of Pace Cars, is not always as distinctive as that shown in Figure 3. Some observations show less triangle and/or various degrees of silver overspray but if looked closely the triangular pattern is notable.

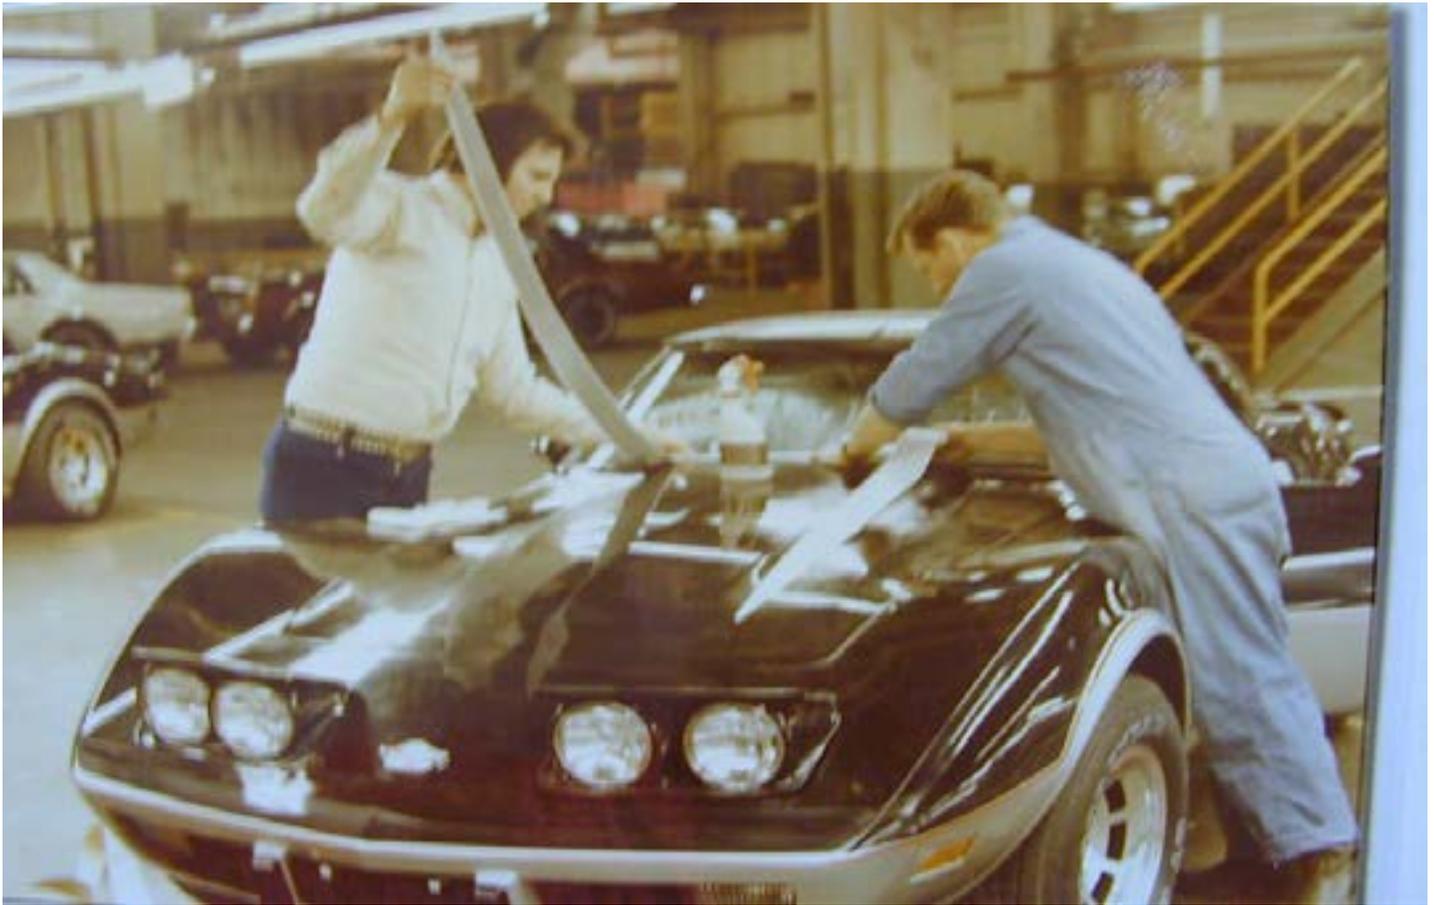
Figure 4: Application of Decals

The Final Process area of the Impala plant was used to apply Pace Car decals per the Assembly Instruction Manual. An additional instruction sheet GM# 476285 was included with decal box GM# 476282 for application by either the dealer or the owner. Only the body pin stripes, hood decals, and the “Limited Edition” under the cross flags were applied at the factory. Figure 4 shows workers applying the decals to the hood. Note the Impala in the background while the Pace Car is in the foreground, which supports the view that decal assembly occurred in the Final Process of the main assembly plant at the St Louis campus. Notice as well that the spoiler is not installed, a topic covered in the next section.

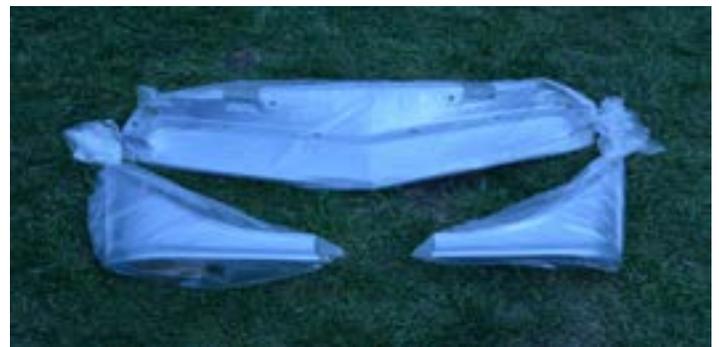
Figure 5: Three-Piece Front Spoiler in plastic bags

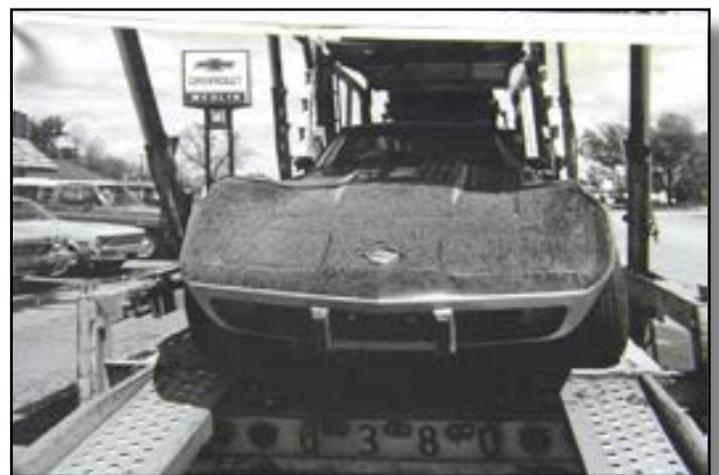
Figure 6: Pace Car on freight truck without spoiler

Steel ramp freight trucks used could not accommodate the low-profile Pace Car with installed air deflectors. The shipping company, Anchor Motor Freight used a metal grid plate system on trucks that scrapped lower panels of low-profile vehicles.² Dealers received a fee for dealer preparation and the Pace Car's front spoiler was authorized as a dealer preparation item. A few more years would lapse before ramps were engineered and installed to accommodate low-profile vehicles. The C4 era had a black plastic spoiler that was not installed by the factory but part of dealer preparation.
